SUBJECT: RECALL R05JN INADVERTENT ENGINE SHUTDOWN

Inadvertent Engine Shutdown

MODELS AFFECTED: All Blue Bird Visions delivered through March 01, 2005

R05JN
RECALL CAMPAIGN

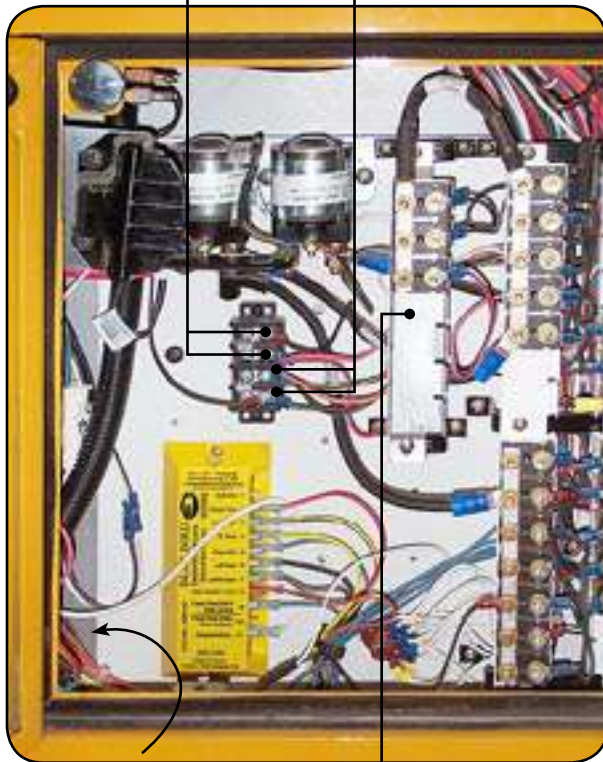
T/S 1 Terminal Block

The wire numbered 1168 will be entirely removed from the harness and discarded.

All other wires connected to these two terminals will be relocated to a new breaker.

The bottom two terminals of the Terminal Block will not be altered.

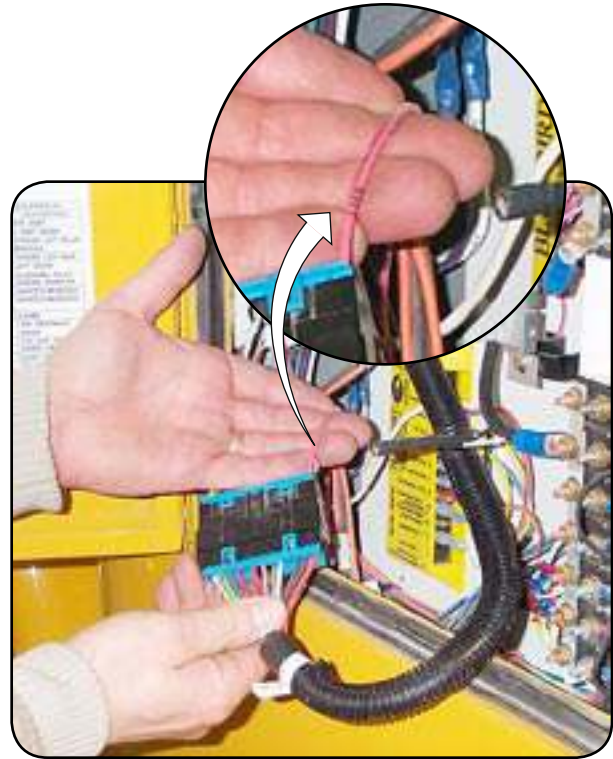
Circuit Breaker Bracket

The Body Harness Connector affected in this procedure is tucked behind the left bottom corner of the panel door post.

New breaker will be installed here, with relocated accessory wires attached.

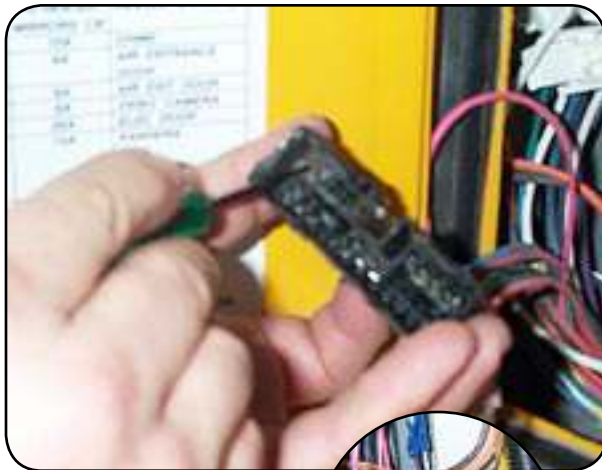
Wire 1168 removed from body harness connector.

3.3 Using a small screwdriver, mechanic's pick, or other suitable instrument, depress the internal clip which retains the 1168 wire's end terminal. Remove the terminal from the connector block.
