R07MS

**SUBJECT: RECALL R07MS BRAUN WHEELCHAIR LIFT  
NONCOMPLIANCE-THRESHOLD  
WARNING SIGNAL RECALL**

# Service Bulletin 34273

Instructions for Braun Corporation "Public and Private Use" Dual Parallel Arm Lift Threshold Sensitivity Evaluation and NHTSA Compliance Applicable for NL, NCL and NVL Series Lifts

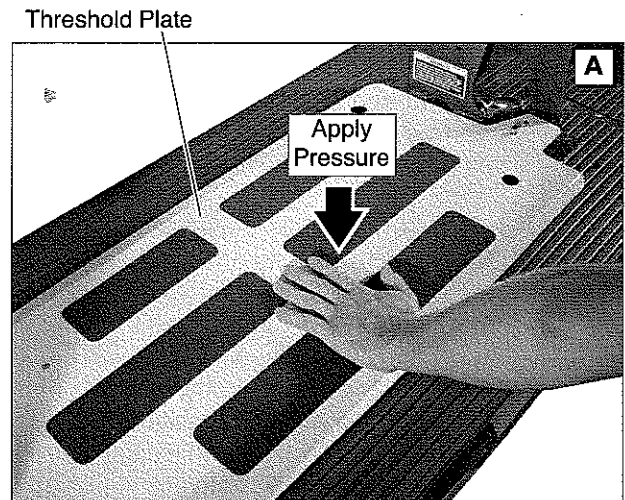
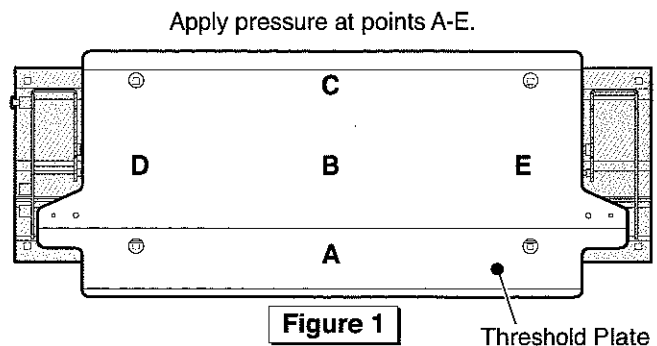
1. Turn Lift Power switch ON. Deploy the lift platform fully to the ground.
2. Apply hand pressure on the center of the threshold plate as shown in Photo A. The visual and/or audible threshold warning\* should be activated when you push down.

Repeat the sensitivity test procedure at positions A-E shown in Figure 1.

If the threshold alarm is not activated at all positions, perform the retrofit procedures detailed on pages 2 and 3 of this bulletin. Repeat the sensitivity test procedures following the retrofit. If the lift still does not meet the requirement, contact a Braun Corporation Product Support representative at 1-800-THE LIFT®.

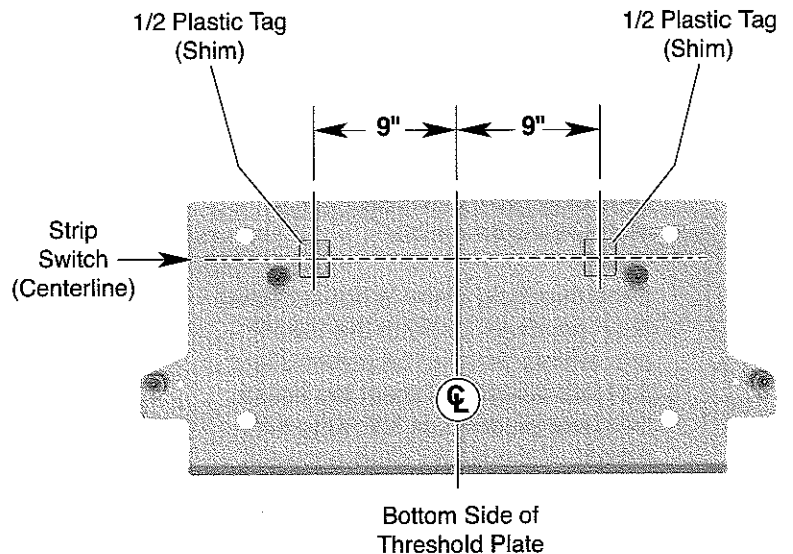
**D**

Turn threshold plate over. See Photo D. The strip switches typically leave an impression (mark) on the yellow plate from use. Use the impression of the inboard strip switch as a centerline for shim positioning (or measure to establish position).

Position each shim 9" from the center of the threshold plate (see Photo D). Align the tags with the strip switch centerline. Clean the surface as detailed below and affix the adhesive-backed tag to the plate (**press firmly**).

**Note:** Clean the surface with isopropyl alcohol before affixing the tag. Use a clean cloth or paper towels. Do not use oily shop rags. Wipe surface free of residue with dry portion of cleaning cloth.

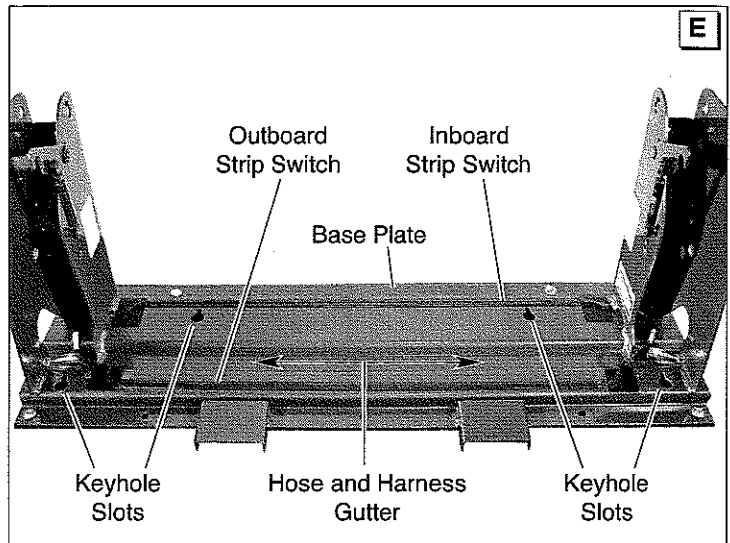
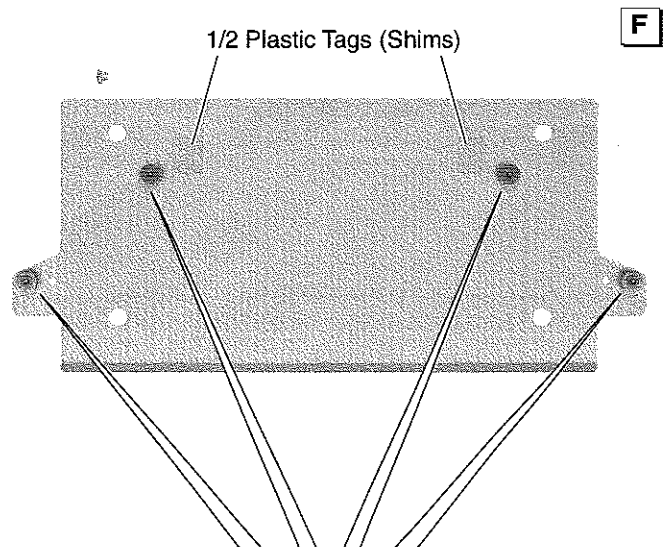
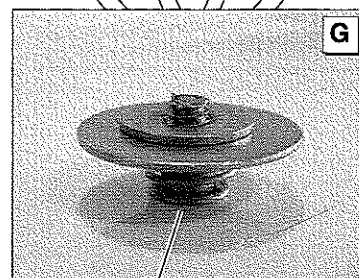
Keeper Standoffs  
(Engagement Studs)

**Ensure** all hoses and wiring harnesses routed through the base plate gutter are positioned fully in the gutter and not located anywhere they could potentially interfere with activation of the tape switches. See Photo E.

4. Reposition the threshold plate (with shim). Align the keeper standoffs (studs) on the bottom of the threshold plate with the base plate keyhole slots. See Photos E, F and G. Insert studs and **carefully** slide the plate inward (engage slots fully).

**Note:** Spraying a light mist of glass cleaner (or other) to the strip switches will aid in the plate sliding easier into position. See Photos E, F and G.

**Ensure** all four keeper standoffs engage the base plate keyhole slots.
