BLUE BIRD

R09PB

SUBJECT: RECALL R09PB BATTERY POWER CABLE ROUTING

MODELS AFFECTED: 2007-2008 BBCV with Caterpillar C7 Engines

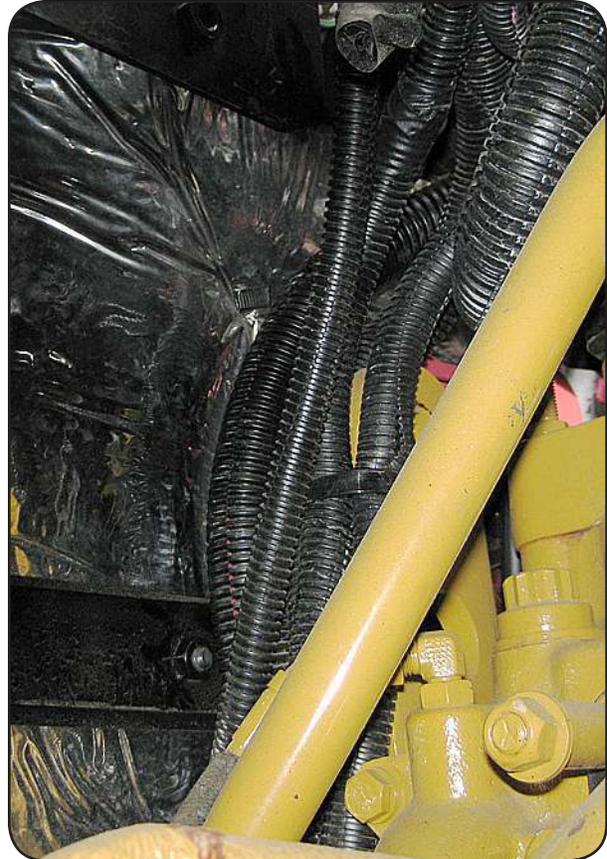
This procedure requires thorough inspection of all battery cables for abrasion damage in the area at the rear of the engine

- 4** Thoroughly inspect all the cables identified in step 3 for indications of contact with and/or chaffing against the rear of the engine. Ensure there is a minimum of 1/2" clearance between the battery cables and any part of the engine.

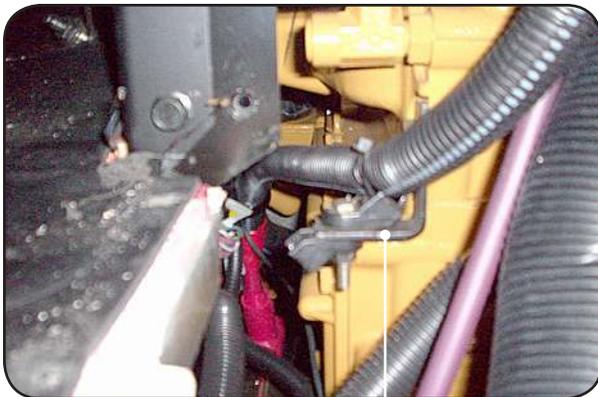
L-shaped bracket

A saddle block is bolted to this bracket, and supports a battery cable, attached by a cable tie. Inspect the battery cable for contact with the saddle block's mounting bolt or with any portion of the engine, as follows:

- If any chaffing or other damage is evident, perform **Sub Procedure A: Cable Protector Installation**.

- If no chaffing or other damage is evident, but clearance between the cable(s) and any part of the engine is less than ½", reposition and secure the cable to obtain ½" clearance. If the cable cannot be repositioned, perform **Sub Procedure A: Cable Protector Installation**.

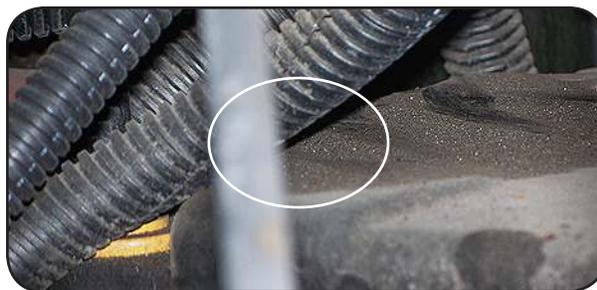
7.3 Inspect the battery cables for any evidence of contact with the rear of the engine, chaffing, or other damage. (Some harnesses may be attached to the engine lifting eye; those are not battery cables.)

Example of battery cable loom resting against engine

- If no damage is evident, and the required 1/2" minimum clearance is provided, proceed to step 8.
- If clearance between the cable(s) and any part of the engine is less than 1/2", perform **Sub Procedure A: Cable Protector Installation**.

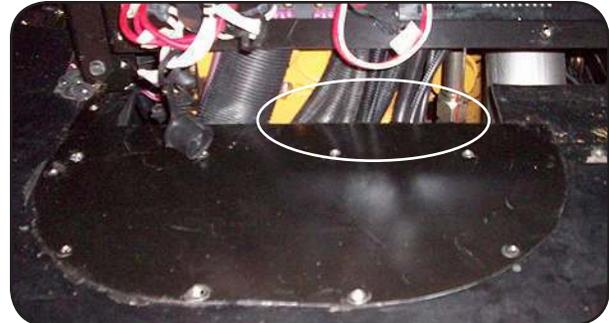
Area of possible cable damage against front edge of transmission cover plate

- If no contact between the transmission cover and harnesses is evident, proceed to step 8.
- If any evidence is found of chaffing or other damage due to contact against the transmission cover, perform **Sub Procedure B: Relocate Transmission Cover**.
