R09PL

**SUBJECT: RECALL R09PL REAR HEADLINER FMVSS JOINT
STRENGTH NONCOMPLIANCE**

Headlining Rivets

RECALL

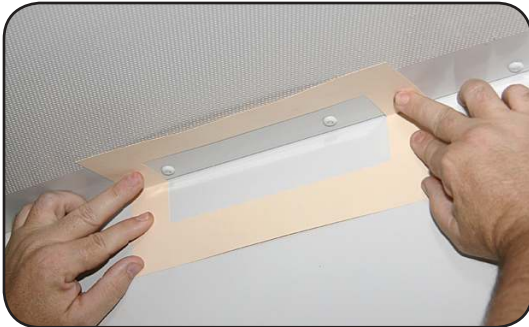
On some units, the rivet spacing may be incorrect in some segments of the rear headlining and rear upper inner panel joint, resulting in noncompliance with FMVSS 221, School Bus Body Joint Strength.

- 1** Park vehicle on level surface, apply parking brake, remove ignition key and chock wheels.
- 2** Inspect rivet spacing at rear headlining and rear upper inner panel joint. Joint must have a minimum of four rivets in an eight inch segment.
 - 2.1 Place the template over the joint and parallel to the edge of the headlining panel, allowing roof rivets to be exposed through the opening in the template as shown.

- 2.2 Move the template from one side of the headlining panel to the opposite side.
- 2.3 If a segment in the rear headlining panel joint contains less than four rivets, additional rivets are required. Mark each area that requires additional rivets. Rivets should be spaced on approx. 2" centers.
- 2.4 If additional rivets are required; add additional rivets between the largest spaces until a minimum of four (4) rivets have been added in the 8 inch segment.
