R09PM

SUBJECT: RECALL R09PM OFFSET LEG BARRIER PAD AND 2/3 PASSENGER SEAT BACK PAD NONCOMPLIANCE

Offset Leg Barrier & 2/3 Seat Back Pads

RECALL

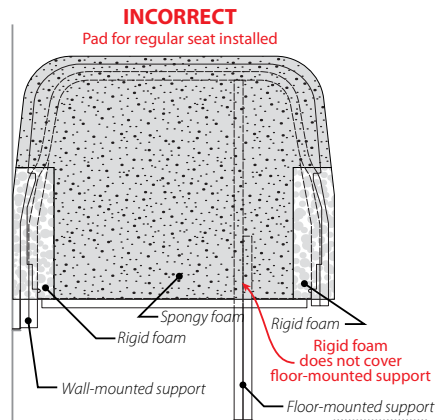
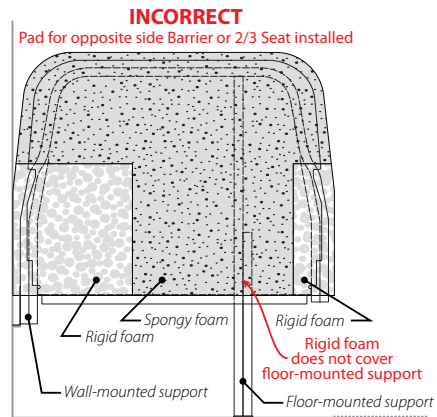
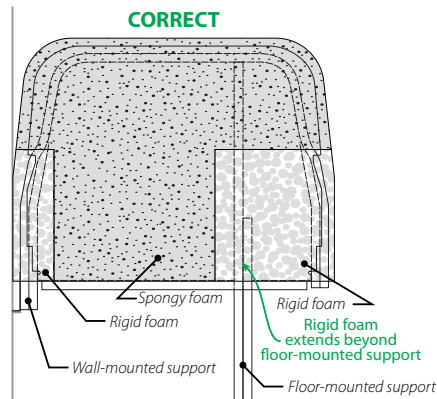
- Correct Pads For Barrier and 2/3 Seat Backs. The offset support legs of Seat Barriers and 2/3 Seat Assemblies extend vertically inside the back frame. These vertical frame members are required to be covered by the rigid foam components of the Pad Assembly.
- Incorrect Pads For Barrier and 2/3 Seat Backs. If a Pad Assembly for a regular full-width seat is installed on a Barrier, or on a 2/3 Seat Back, the vertical extension of the support legs are not sufficiently covered by the rigid foam type.

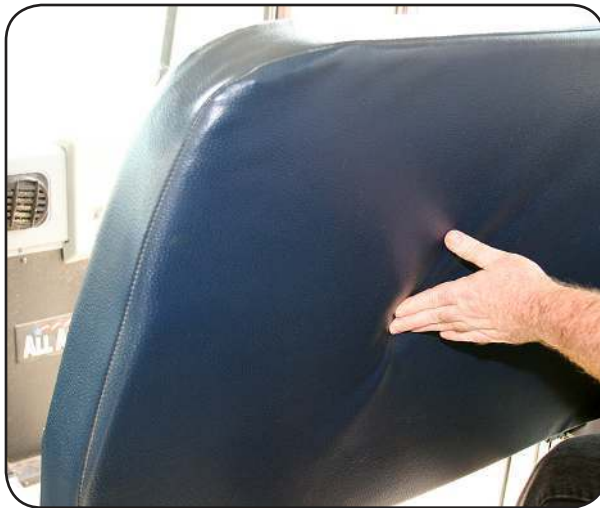
The edge of the rigid foam inside the cover of a Barrier or a 2/3 Seat extends beyond the vertical support leg, which is offset from the aisle-side of the seat.

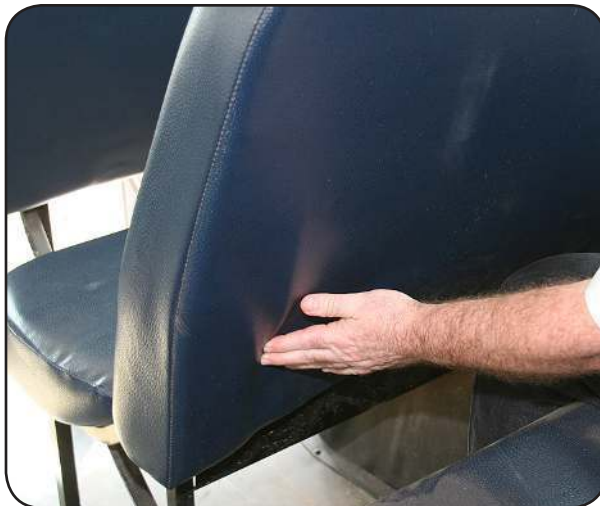
The pad of a regular seat back also has rigid foam pieces, but they do not extend as far from the aisle-side of the seat, because the vertical support leg is not offset.
