BLUE BIRD

R10RK

**SUBJECT: RECALL R10RK BATTERY CABLE ROUTING AT REAR OF
LARGE BATTERY COMPARTMENT**

Models Affected: 2010 All American (D3) Rear Engine Buses Equipped With Feature 00156-09 Heavy Duty Battery Compartment

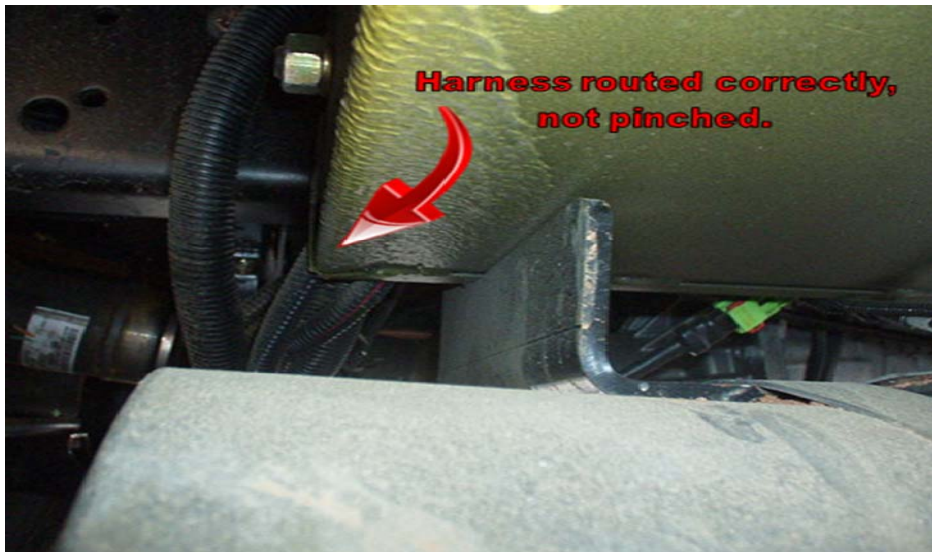
1. Park the bus on a level surface, apply parking brakes, turn off engine and remove ignition key.
2. Chock wheels.
3. If unit has air suspension, place jack stands under frame rails for inspection and/or correction to prevent frame from lowering should air bags deflate.
4. Disconnect Batteries - Note when disconnecting the batteries, remove the Negative cable first.
5. Inspect battery cables. If the battery cables are routed & secured behind battery compartment per photo below, no further action is required.

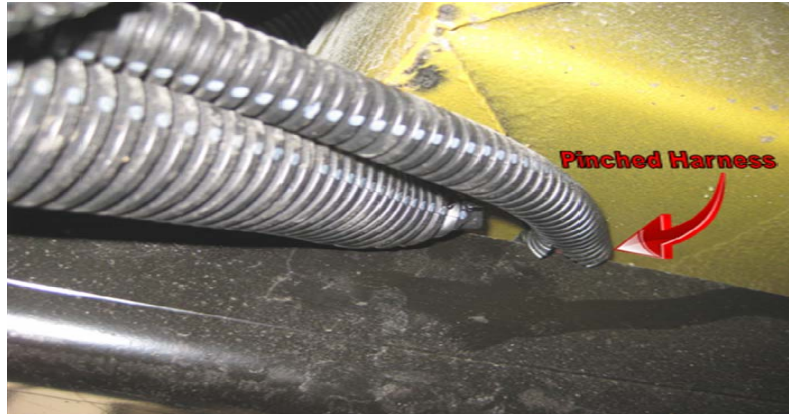
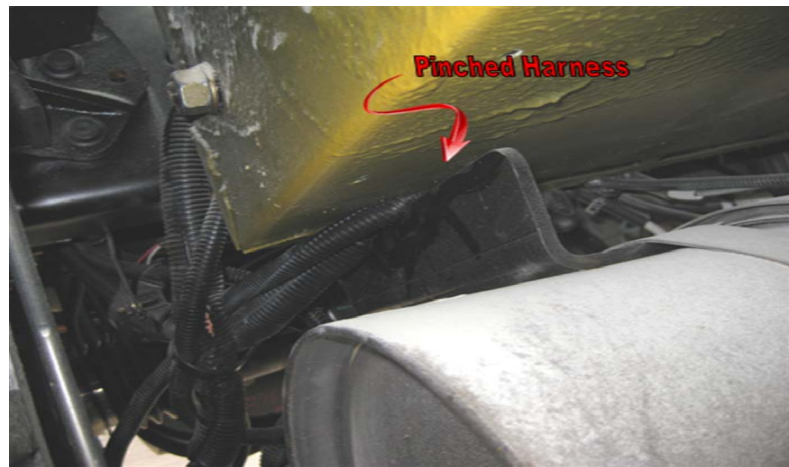
Positive battery cable may be pinched between bottom of battery compartment & muffler mounting bracket. Also, the front muffler exhaust bracket could be mounted in an incorrect location making it too close to bottom of battery compartment.

- 6. If any battery cables are pinched between the muffler mounting bracket and the front bottom side of the heavy duty battery compartment (See photos below) remove the clamps and zip strips securing cable, remove cable from between battery box and the muffler mounting bracket, remove loom and inspect cable for damage to insulation.

- 7. If cable is damaged, disconnect other end reference attached diagram D0003543), remove from chassis and replace w/new cable assembly.
- 8. If cable is pinched but not visibly damaged, then reroute cable to rear of heavy duty battery compartment and re-clamp/secure to hold in place per photo on page 1. Reference diagram D0003543 for cable routing.

Note: Cables must be routed/clamped to prevent contact with exhaust muffler. A minimum of 3 inches must be maintained between cables and exhaust muffler.

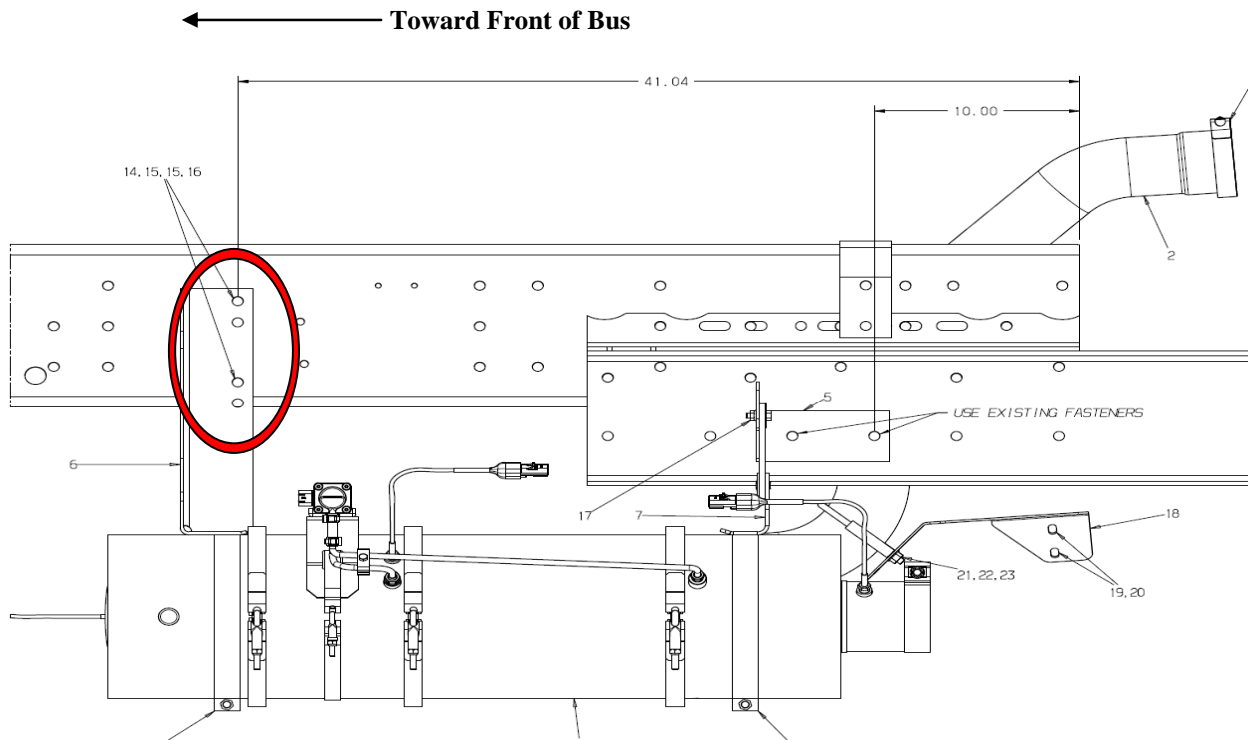
9. If exhaust muffler is contacting the battery compartment, relocate muffler exhaust bracket per diagram below for buses equipped with **Cummins ISB engines**.

Use **upper holes** in the bracket to mount to the **lower frame holes** at 41.04" from the end of frame. *Do not use the frame holes located at 40" from the end of frame.*

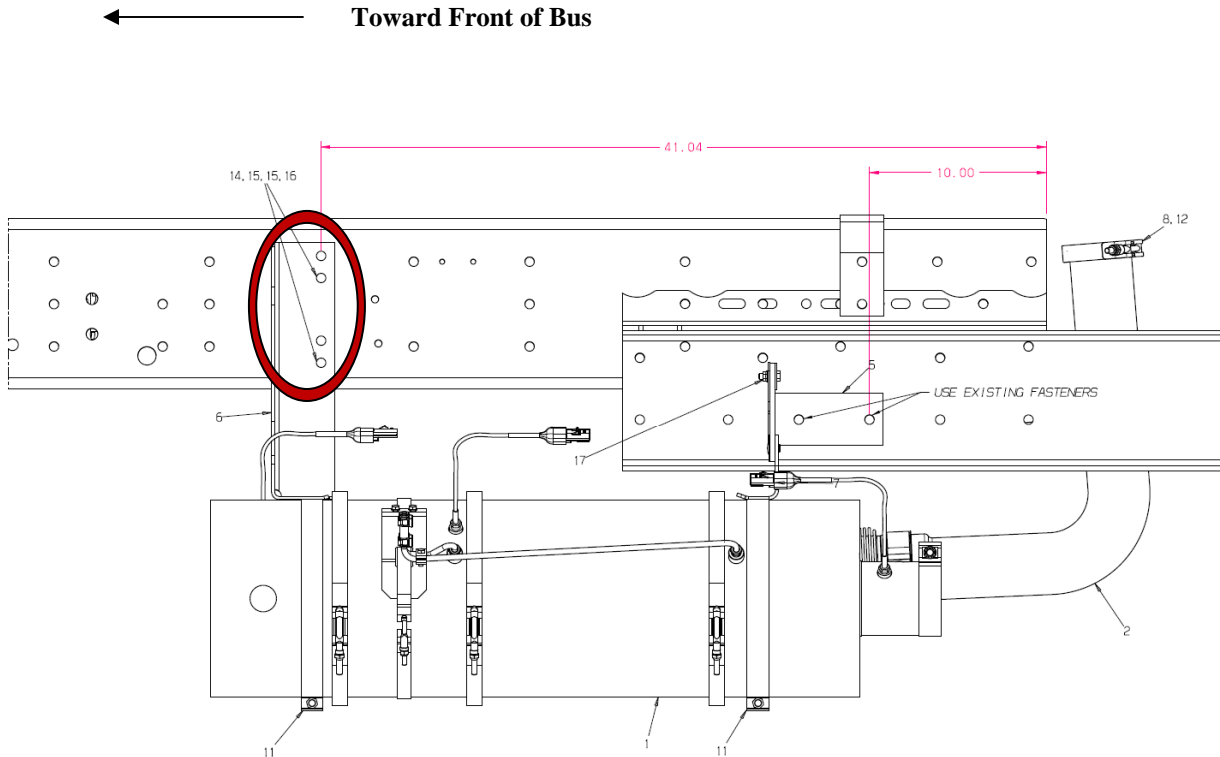
- 12. If exhaust muffler is contacting the battery compartment, relocate muffler exhaust bracket per diagram below for buses equipped with **Cummins ISC engines**.

Use **lower holes** in the bracket to mount to the **lower frame holes** at 41.04" from the end of frame. *Do not use the frame holes located at 40" from the end of frame.*
