DATE: APRIL 14, 2010
TO: U.S. DEALERS
SUBJECT: RECALL R10RR TAG LIGHT WIRING CONNECTOR CORROSION

Tag Light Wiring Connector Corrosion

Models Affected: 2010 All American Front Engine

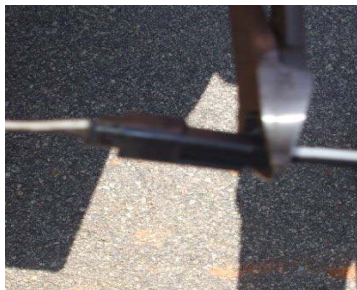
The All American tag light harness was not manufactured to design specifications. The harness length was incorrect which allowed the connector to be routed incorrectly exposing the connector to the environment and possibly allowing the connector to corrode.

1. Park the bus on a level surface, apply parking brakes, turn off engine and remove ignition key. Chock wheels.
2. Read all instructions completely before proceeding with repair.
3. Check to see if the 2-wire connector for tag light in LH rear corner of unit is exposed underneath floor of unit. If 2-wire connector is exposed, follow the instructions below to correct. If the 2-wire connector is not exposed outside of body cavity, return unit to service.
4. Disconnect Batteries – Note: when disconnecting the batteries, remove the Negative cable first.
5. Use wire cutters to cut both wires immediately adjacent to each end of the 2-wire connector.

Replace tag light connector with sealed butt connector splices per instructions below.

6. Strip approximately ¼ inch of insulation from end of wires extending from body and end of wires attached to tag light.
7. Reconnect white wires using (1) 00005840 sealed butt connector and reconnect black wires using (1) 00005840 sealed butt connector. Be sure to use correct crimping tool for butt connectors. Using heat gun, heat full length of each butt connector until clear sealant in connector starts to melt and bubble up at end of butt connector, while being careful not to melt wire insulation.
8. Install split corrugated loom (01510775) over the tag light harness.
9. Reconnect batteries – Note: when connecting the batteries, connect the Positive cable first.
10. Remove wheel chocks and return unit to service.
