**BLUE BIRD**

**R07LW**

**SUBJECT: RECALL R07LW FMVSS 217 "BUS EMERGENCY EXITS AND WINDOW RETENTION AND RELEASE" NONCOMPLIANCE**

# Emergency Exits

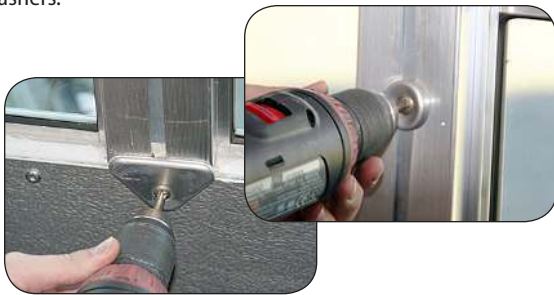
**4** From inside bus, remove 6 window retaining screws and washers.

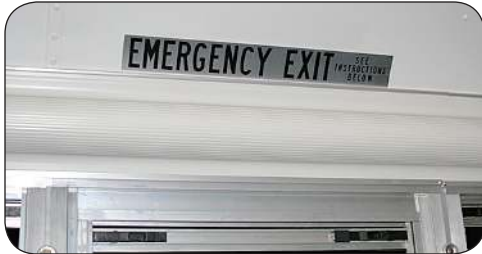
18.1 Apply decal #1495399 (**EMERGENCY EXIT-SEE INSTRUCTION BELOW**) directly above window on headlining panel. **Do NOT** apply to wire molding.

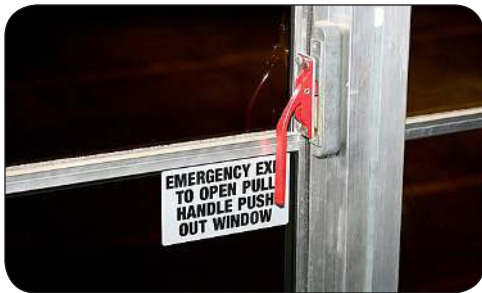
18.2 Apply decal #0812222 (**EMERGENCY EXIT TO OPEN PULL HANDLE PUSHOUT WINDOW**) to glass. Locate decal on lower sash glass 6 inches from latch handle.

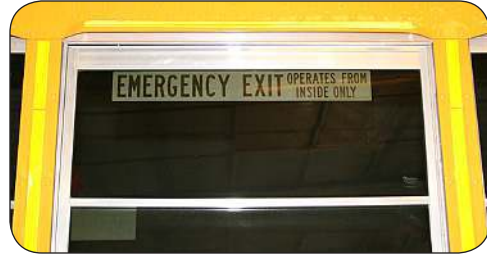
18.3 Apply decal #1495530 (**EMERGENCY EXIT-OPERATES FROM INSIDE ONLY**) at top and centered on upper sash glass. Decal to be read from outside bus.
