BLUE BIRD

R09PB

SUBJECT: RECALL R09PB BATTERY POWER CABLE ROUTING

MODELS AFFECTED: 2007-2008 BBCV with Caterpillar C7 Engines

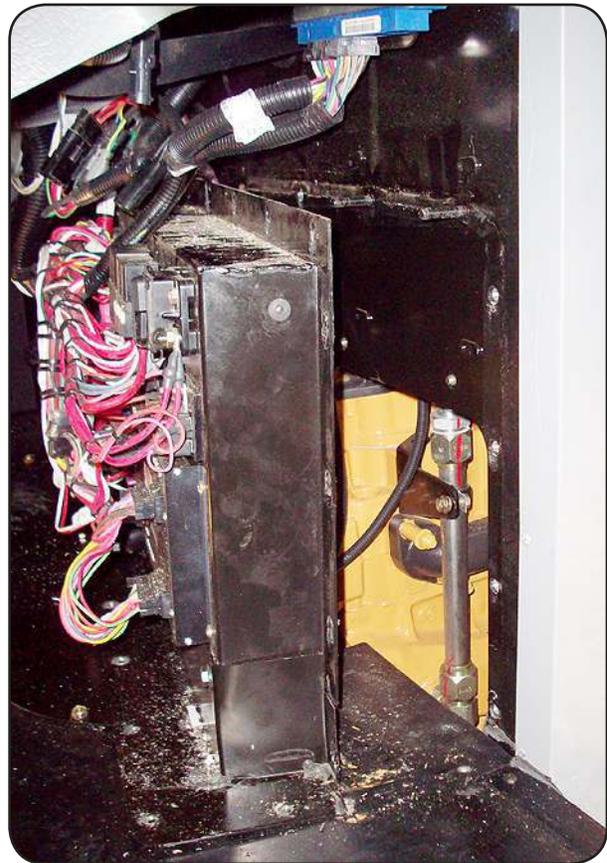
PDU pulled outward at right side to gain access to cables at rear of engine

7.1 Remove the fasteners which mount the PDU. Carefully slide the right side of the PDU rearward far enough to view the wiring behind the engine.
