**SUBJECT: RECALL R08NC FMVSS 221 SCHOOL BUS BODY JOINT
STRENGTH NONCOMPLIANCE-INCORRECT
RIVET PATTERN IN REAR ROOF CAP**

**RECALL R08NC
INSPECTION SHEET**

Rear Roof Cap Rivets

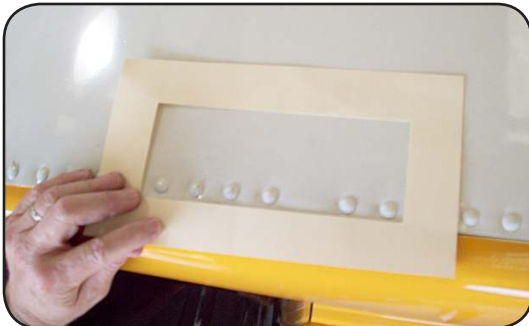
2.1 Place the template over the joint and parallel to the edge of the roof sheet, allowing roof rivets to be exposed through the opening in the template as shown.

2 Inspect rivet spacing at rear roof sheet and rear roof cap joint. Joint must have a minimum of six rivets in an eight inch segment.

2.2 Move the template from one side of the rear roof cap to the opposite side.

2.3 If a segment in the rear roof cap joint contains less than six rivets, additional rivets are required. Mark each area that requires additional rivets.

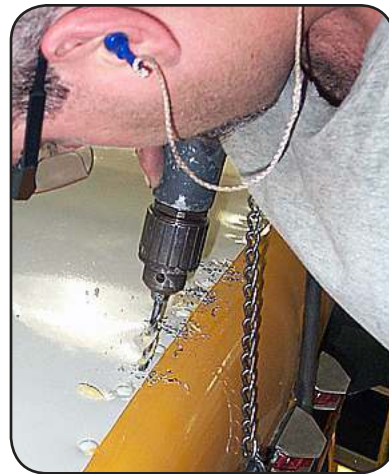
3 Install rivet/s at each mark. Using a short 17/64" drill bit, drill a hole through the roof cap, roof sheet, and rear bow flange. Be sure to drill hole on a common centerline with existing rivets.

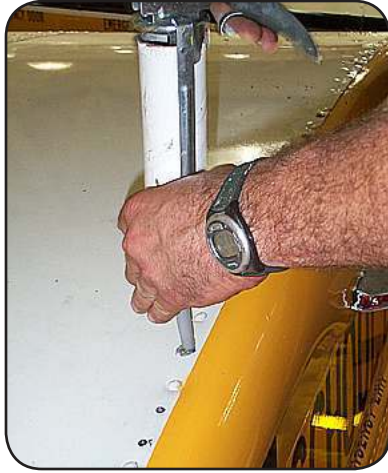
4 Place a small amount of Vinyl Gray 5522 Sealant (Blue Bird # 0898627) in each drilled hole.

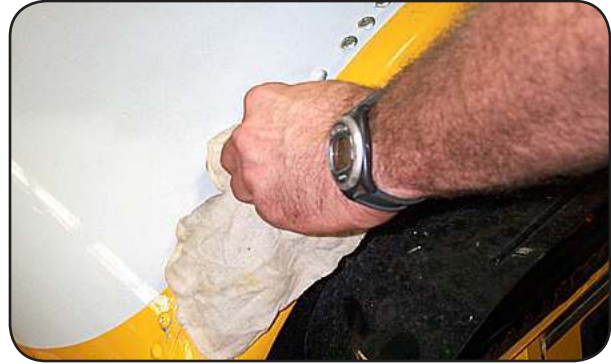
6 Clean up any sealant that may have squeezed out or smeared during rivet installation.

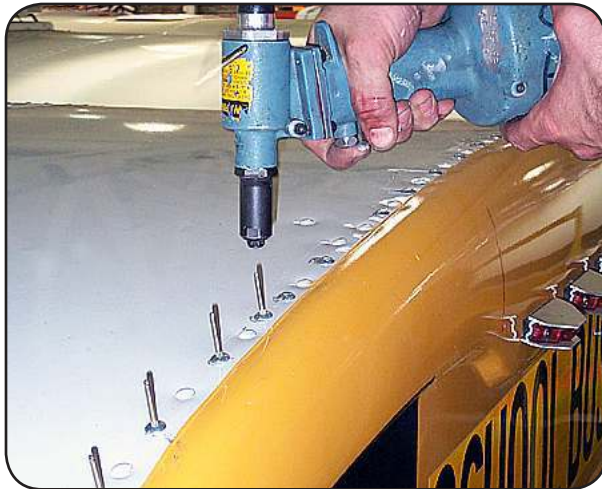
5 The supplied 1/4" blind rivets (Blue Bird # 1854397) are pre-painted white or school bus chrome yellow. Install a rivet of the appropriate color into each hole.

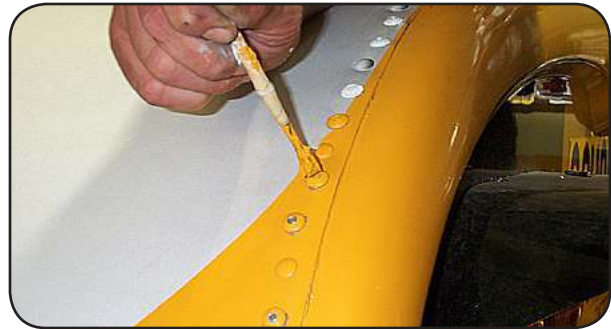
7 With the correct color paint, touch up the center of each blind rivet where the stem was removed during installation.
