R09PY

**SUBJECT: RECALL R09PY FMVSS 221 SCHOOL BUS BODY JOINT  
STRENGTH NONCOMPLIANCE-INCORRECT  
NUMBER OF RIVETS IN FRONT ROOF CAP**

## Front Roof Cap Joint Strength Noncompliance

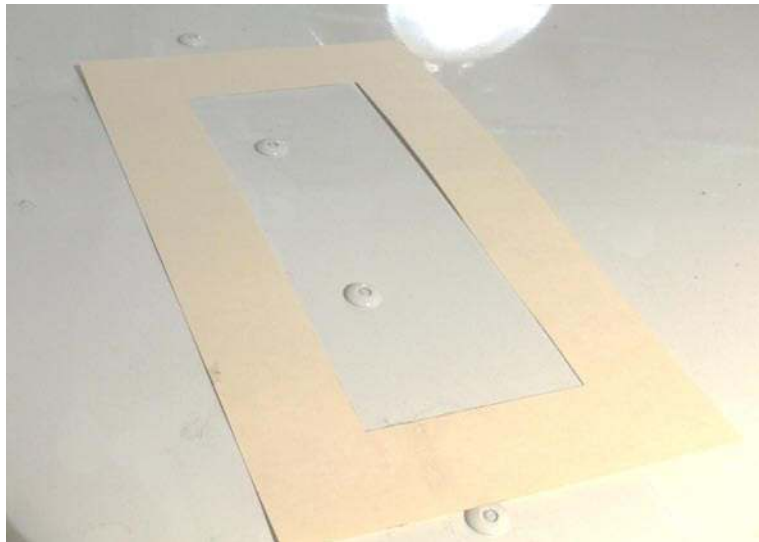
1. Inspect rivet spacing at front roof cap and front roof sheet joint. Joint must have a minimum of four rivets in any eight inch segment.
2. Place the template over the front roof cap joint rivets and parallel to the edge of the front roof cap, allowing front roof cap rivets to be exposed through the opening as illustrated below.

3. Move the template from one side of the front roof cap to the opposite side.
4. If a segment in the front roof cap joint contains less than four rivets, additional rivets are required. Mark each area that requires additional rivets.

5. If one rivet is required; add a rivet equally spaced between the two rivets with the largest space in this section.
6. If additional rivets are required; add additional rivets between the largest spaces until a minimum of four (4) rivets have been added in the eight (8) inch segment.
7. Install rivets at each mark. Using a **short** 17/64" drill bit, drill a hole through the roof cap, roof sheet, and bow flange. Be sure to drill hole on a common centerline with existing rivets.
8. Place a small amount of Vinyl Gray 5522 Sealant (Blue Bird #00898627) in each drilled hole.
9. Install 1/4" blind rivets (Blue Bird # 01854397) into each hole.
10. Clean up any sealant that may have squeezed out or smeared during rivet installation.
11. Using the correct color paint, touch up the center of each blind rivet where the stem was removed during installation.
